NEICO AVIATION INC.

Service Bulletin 001-90

Subject: Lancair IV elevator control horn weldments

Date: August 20, 1992

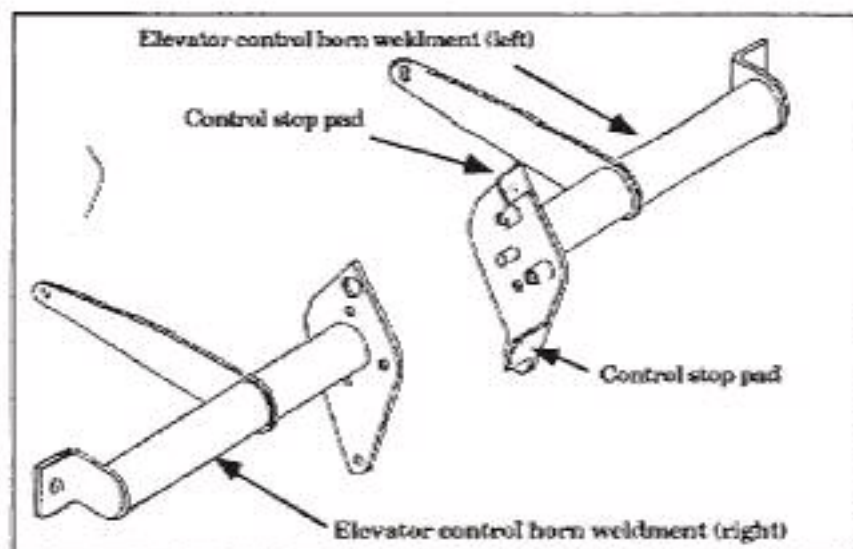
It has come to our attention that there was a batch of elevator control horn weldments that did not contain the elevator "control stop pads." These small pads are used when setting the elevator control travel limits.

Please inspect your components to verify that the two pads are included. See drawing below.

IF your control horn weldment does not have these pads, replacement will be necessary.

1. Send both component pieces (left and right) to Neico Aviation Inc., 2244 Airport Way, Redmond, OR 97756
- 2 Reference, on the OUTSIDE of the box, this service bulletin number, S13008-92.

We will promptly correct the situation and return the proper weldments to you. The corrected weldments are direct replacements and should not affect rib or bolt placement in the elevator.
