## SERVICE BULLETIN

## SB017-494

Subject: Lancair IV  
Date: 7<sup>th</sup> April, 1994  
Ref: None  
Pages: 2  
Status: Advisory

### 1. HAND PUMP CHECK VALVE LOCATIONS:

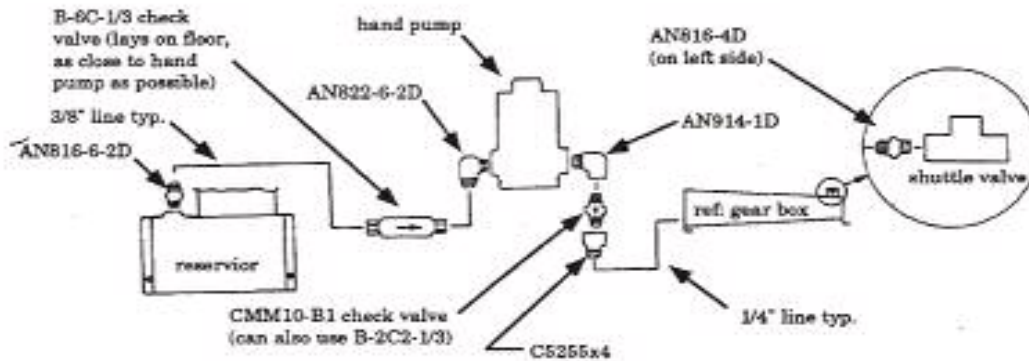
We are now recommending a modification to the hydraulic hand pump installation. The originally shipped instructions indicated installation of the hand pump check valve as being removed (on the reservoir for the supply side and at the shuttle valve for the pressure side).

While this works very well on our aircraft, failure analysis shows that a safer installation does exist and for this reason of increasing safety/reliability, we are recommending the installation change.

We will briefly highlight the installation changes in this writing in an effort to provide you the earliest possible notice and will follow with revised plans. The changes are quite easy to make and we strongly recommend that you opt for this revised installation.
