SERVICE BULLETIN

SB024-1294

Subject: Matco Brake Plat Alignment / Lancair 320 / 360

Date: 14th December, 1994

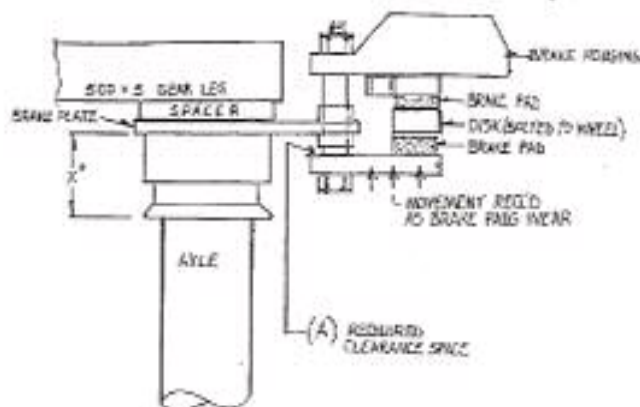
It has come to our attention that a potential clearance / alignment problem could result when assembling the axle / brakes on recent models of Matco brakes due to part changes by Matco. The potential problem is that the new Matco brake plates were changed. They now have symmetrical bosses on which the brakes slide in and out. As brake pads wear, the need for additional travel clearances becomes even more critical.

If the assembly is not installed with adequate travel available, then the result is that only one side of the brake rotor and pad would make contact and braking power would be greatly reduced. We recommend that you inspect your assembly and check for clearances and alignment.

1. If you have already installed your brakes, make a simple check to verify that the brake pad assembly has travel room. The brake pads should both have contact against the disk and there must be a gap (approx. 0.080") at location (A). This space is necessary to provide clearance (travel room) as the pads wear down.

We have modified our axles (late model) such that the dimension (X) is now 1.40" vs. the earlier 1.30". If you have the 1.30" style axle and are using the 500 x 5 gear installation, then the position of the supplied spacer can be switched with the brake plate during installation. By placing the spacer on the axle first followed by the brake plate, you will gain approx. 0.125" of additional clearance.

2. If you appear to have a travel clearance problem and are not sure how to correct it, please call Pat at Neico Aviation.
