SERVICE BULLETIN

SB025-495

Subject: Lancair IV flap track attachments

Date: 10th April, 1995

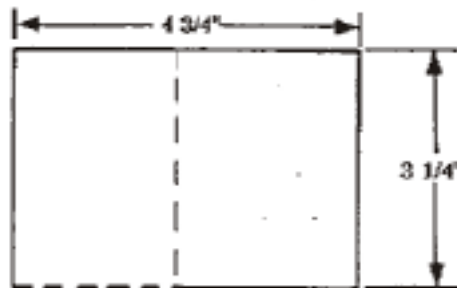
- B19. Support for the flap tracks is mentioned back in Chapter 7, page 7-27. Notice in Figure 9:B:11 the dimensions for cutting the 10 BID.

10 BID Support Pattern

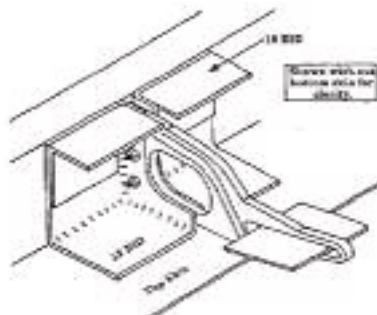
Figure 9: B: 12

Notice in Eigure 9:B: 12 how the BID ends between the bolt holes. It should extend over half way down that side.

Placement of the 10 BID

- B20. Apply the 10 BID support to each side of the flap tracks on the **right wing only**.

For the **left inboard** flap track, apply 10 BID on the outboard aide only. (The bellcrank is positioned in such away, on the inboard side of the flap track, that it serves as a support.) The bellcrank for the **left outboard** flap track is spaced approximately 1" from the flap track, Apply 10 BID to both sides of this flap track, but trim the BID carefully for the side with the 1" space.
