**SERVICE BULLETIN**

**SB027-0196**

Subject: Lancair IVP main gear box reinforcement  
Date: January 17<sup>th</sup>, 1996  
Ref: None  
Pages: 3  
Status: Mandatory Inspection

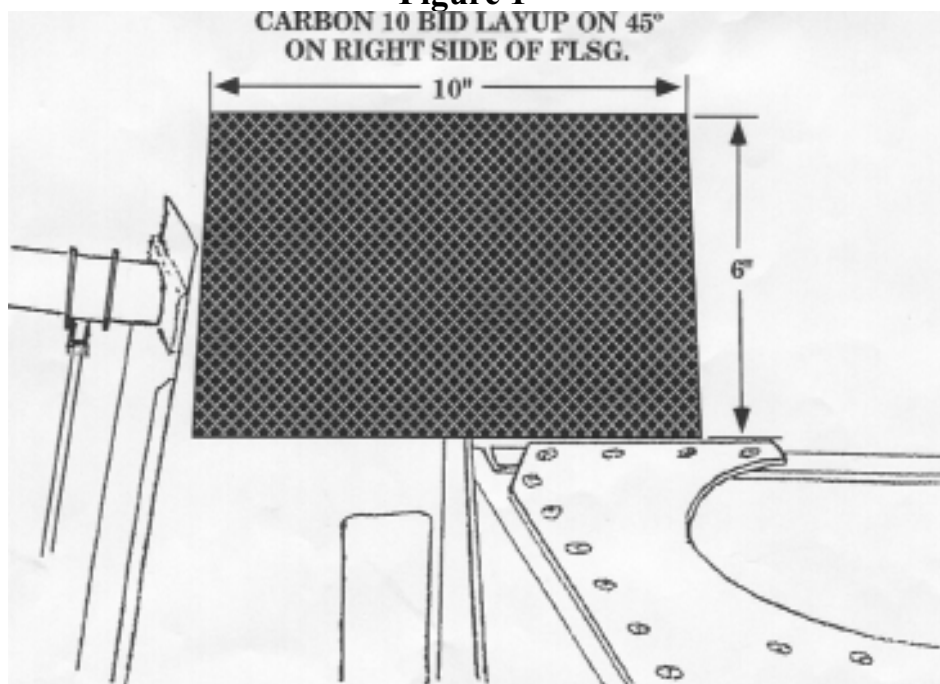
**Figure 1**

During an inspection of a customer's Lancair IVP during a pressurization test, it was discovered that the 24 BID in the area just above the gear box on the forward right side had debonded. The 24 BID distributes the load of the machine screws securing the GM461-002 bracket and also serves as a stiffener. None of the other IVP's (including the company prototype) have shown similar signs of debonding. However, the following modification is recommended as a precautionary measure.

Refer to the illustrations on the next two pages.
