**SERVICE BULLETIN**

**SB033-0597**

Subject: Lancair IV and ES

Ref: Fuel Valve

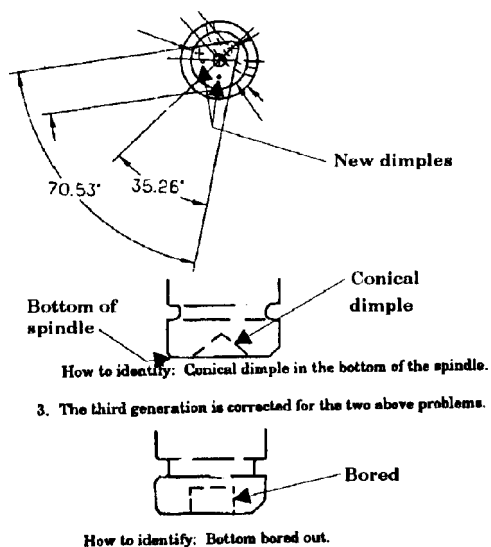
The Fuel Valve should turn easily. If you are having trouble turning the valve you should make sure that you have installed the new spindle and Viton O-rings. The new spindle valve has a straight walled "bore" cut into the bottom of the spindle and 2 dimples in the top. The significant difference between these spindles is: Increased O-ring glands cut into the spindle side to put less pressure on the O-rings.

While the engine is running turn the valve to the off position. The engine should shut down in 30 to 90 seconds. If it doesn't, please call inventory and get a return authorization number and we will replace the valve.
