SERVICE BULLETIN

SB034-0597

Subject: Lancair IV and ES

Ref: Applies to IV and ES TSIO -550 and IO-550

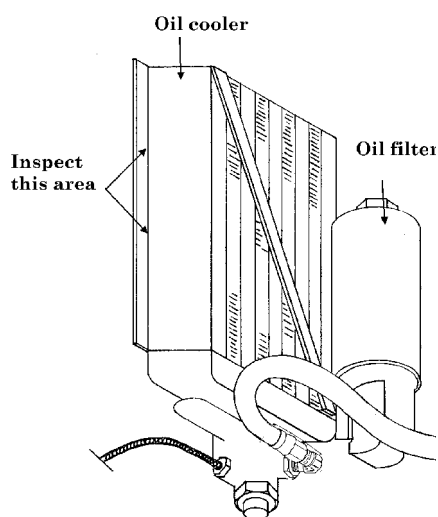
During a recent annual we noticed an oil cooler flange crack on the Lancair IV's TSIO - 550 and the Lancair ES's IO-550. The crack is normally located on the left flange and runs along the bend in the cooler. Keep in mind that the bend is located on a piece of the cooler that does not contain any oil.

Inspect and repair if needed.

Put a bead of weld along the bend area of the oil cooler.
