SERVICE BULLETIN

SB037-0797

Subject: Gear Leg Witness Hole (Lancair IV & IV -P)

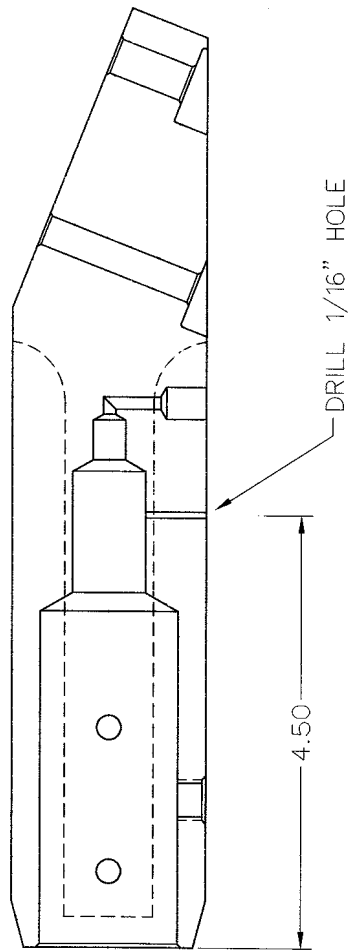
Background: The Lancair IV gear leg has an internal brake line. This also means there is an internal hydraulic fitting as well. We have had reports of a leak coming from the lower GM455 machined end on the bottom of the leg. If a leak was to occur at the internal fitting of this part, it could take a while to discover.

Action: Drill a “witness” hole either in place on the airplane, or disassemble the lower leg and brake line system and drill the hole on a bench. Either way you should use a solid bit stop to prevent the bit from passing too far through the wall, which could result in damage to the fitting. Use a small bit, about 1/16” in diameter, and drill a hole set to a depth of 0.640”. Because the wall thickness is only 0.630”, this should be sufficient.

Note: During each preflight, inspect the witness hole in the leg and look for any signs of brake fluid. If you find some, you have an internal leak and it should be fixed before flight.
