SERVICE BULLETIN

SB042-0298

Subject: Lancair IV and Lancair ES Fuel Vent Lines
Date: 13 Feb. 98
Ref: None.
Pages: N/A
Status: Mandatory Inspection and Replacement (if necessary)

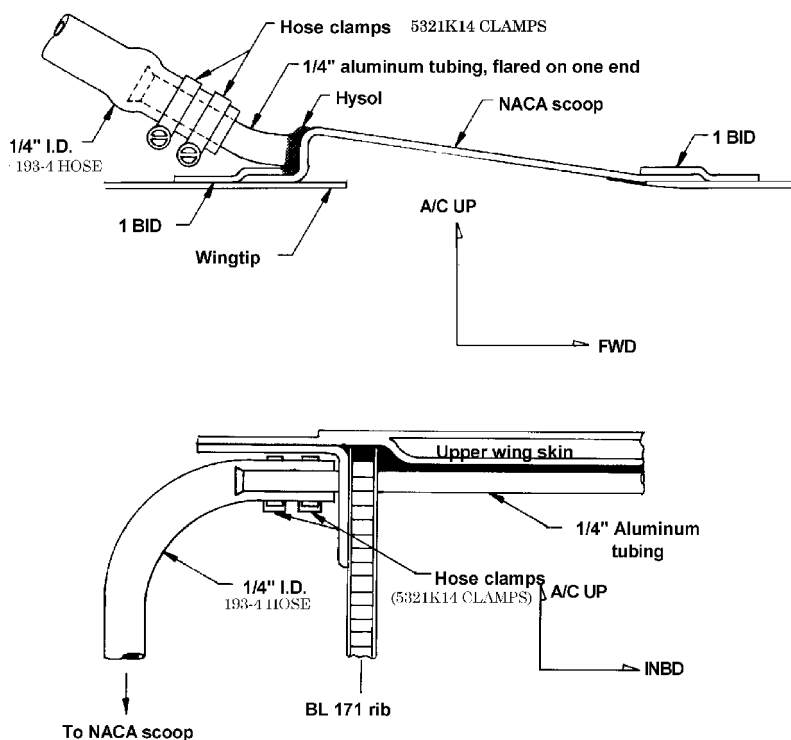
Fig. 1

We have noted a degradation over time of the hose that connects the NACA scoop to the aluminum vent line of the fuel tank. After several years of use, the hose apparently is affected by the fumes from the fuel tank and it tends to become “rubbery”. A collapse or complete blockage of this hose could cause engine failure.

Fuel Vent Line Connection to NACA scoop

Visually inspect the vent line. If there are any signs of damage or if in doubt, replace the hose with 1934 hose available through Lancair. Use 5321K14 clamps to secure hose.
