**SERVICE BULLETIN**

**SB044-0998**

Subject: Lancair Central Flap Actuator Cylinder Bellcrank (Lancair IV & IV -P)

Ref: Part Number FL161-01

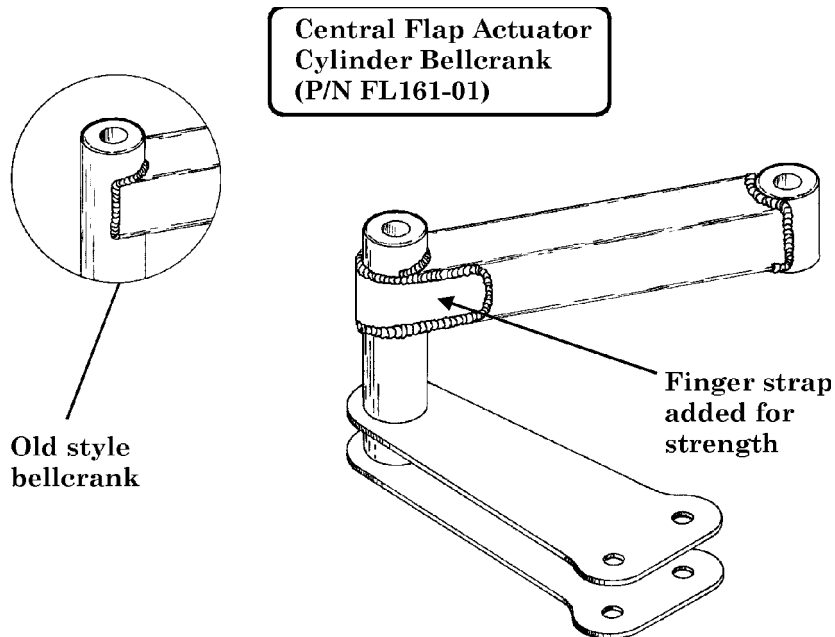
**Background:** We've had one case where this bellcrank's upper arm (that attaches to the flap actuating cylinder) has cracked. While static tests have repeatedly been satisfactory, we still feel that it is important to add a "finger strap" to this component which will prevent any possible breakage.

**Action:** This is an exchange program on a shared cost basis. Please remove and return your existing FL161-01 and we will immediately replace it with the modified version. The exchange cost is \$35.00. If your aircraft is flying and you need a very fast turnaround, please contact our office and we will expedite.
