**SERVICE BULLETIN**

**SB049-0399**

Subject: Lancair Main Gear Hydraulic Cylinder (Lancair IV, IV -P)

Date: 15 March, 1999

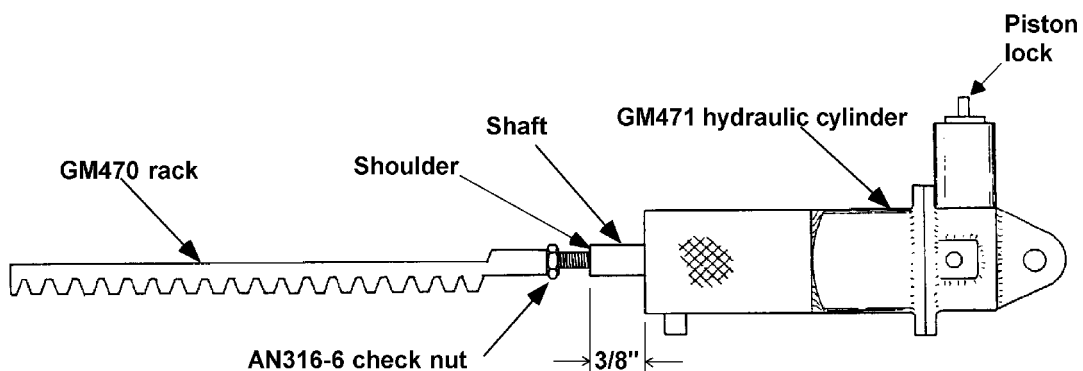
**Figure 1.**

**Background:** On two occasions the cylinder shaft has unscrewed itself from the piston during initial rack position adjustment. There is no known case of the piston continuing to unscrew itself from the rod during normal operation once the initial rack adjustment has been made. However, if the piston did continue to unscrew itself from the rod, the landing loads could be transferred through the pinion, rack, and cylinder causing component failure.

With the aircraft sitting on its gear, accurately measure the length of the shaft between the cylinder housing and the shoulder where the threads begin. It should be  $3/8$ ". If so, no further action is required. Recheck this length every 100 hrs.
