**SERVICE BULLETIN**

**SB050-0999**

Subject: Lancair Main Gear Reinforcement (Lancair 200,235,320,360)  
Date: 5 September, 1999  
Ref: Construction manual, chapters 3 & 5 standard, chapter 2 fast build  
Pages: 2  
Status: Mandatory

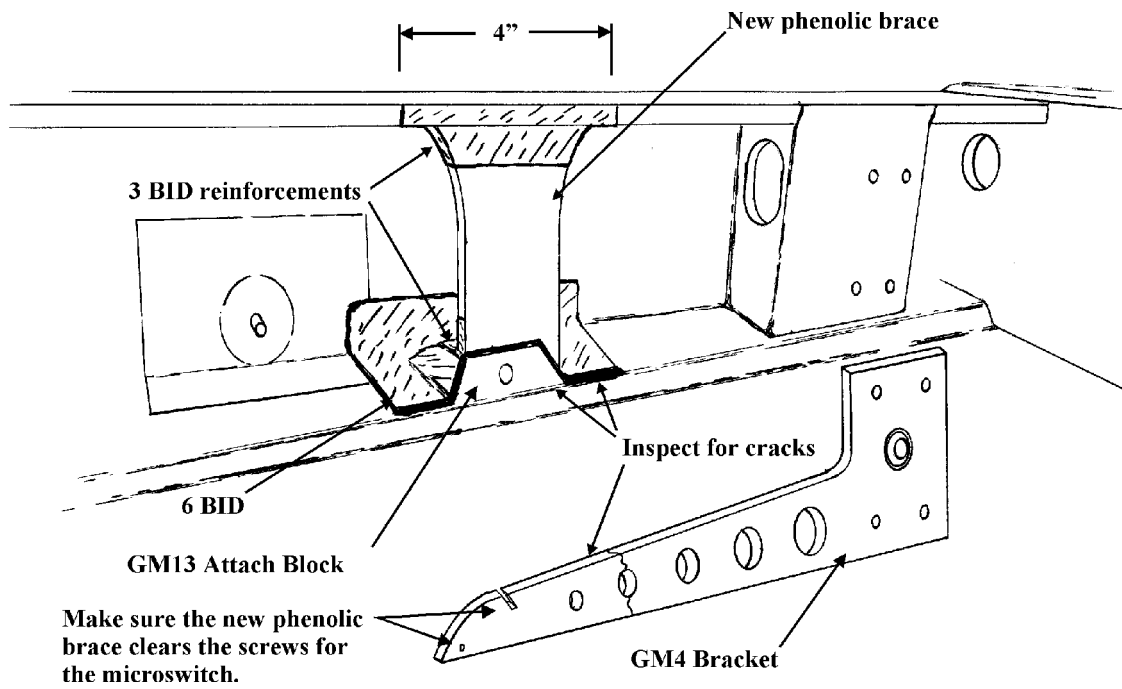
Figure 1

**Background:** On several occasions the secondary main gear attach block (GM13) has broken loose from the lower spar cap. On at least one occasion the 6 BID over the GM13 delaminated as well, transferring all side loads to the GM4 (GM004L & GM004-R) brackets. The GM4 bracket cracked from excessive strain and broke at the inboard lightening hole (later versions don't have the lightening hole) causing the gear to partially collapse.

5. Install a 1/4" thick phenolic brace with Hysol/flox. Make sure the screws for the microswitch will clear. Place a 3 BID at the top and bottom of the brace and let cure. See figure 1. Re-assemble the main gear.

6. If there is only delamination between the GM13 and the lower spar cap, apply a side load to the main gear leg and (after cleaning) push some Hysol/flox into the crack under the GM13 attach bracket. Release the side load and look for good squeezeout. Install the 1/4" phenolic brace (see figure 1). Re-assemble the main gear.

7. We consider the added ¼" phenolic brace as mandatory in all cases within the next 20 hours. Flight during this time period is acceptable provided close inspections are made after landing.

NOTE: Apply the lower 3 BID reinforcement to the backside of the support.
