SERVICE BULLETIN

SB052-1299

Subject: Lancair Flap Track Travel (Lancair IV, IV-P)

Date: 10 Dec., 99

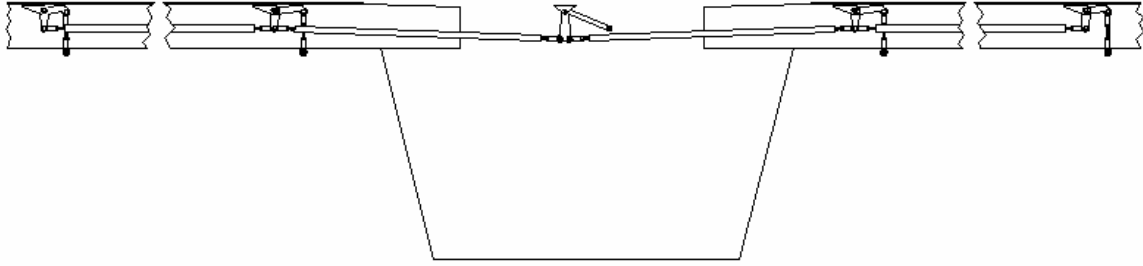
Fig. 1

On some installations the flap cylinder stroke may exceed the travel available in the flap tracks causing unnecessary loads on the flap system components. This condition could cause component failure.

1. Remove necessary panels to access the flap control system.
2. See fig.1, which follows. Recheck the alignment of the wing mounted bellcranks (P.7-87 in IV manual and P.7-13 in IV FB manual) and alignment of the wing mounted bellcranks with the center bellcrank (P.21-9 thru P.21-12).

See manual Pg. 21-10 B2. Align the bellcranks as accurately as possible.
