SERVICE BULLETIN

SB054-0600

Subject: Lancair 235 & 360 Main Gear
Date: 21st June, 2000
Ref: Figures 1 & 2
Pages: 1
Status: Mandatory Inspection Required

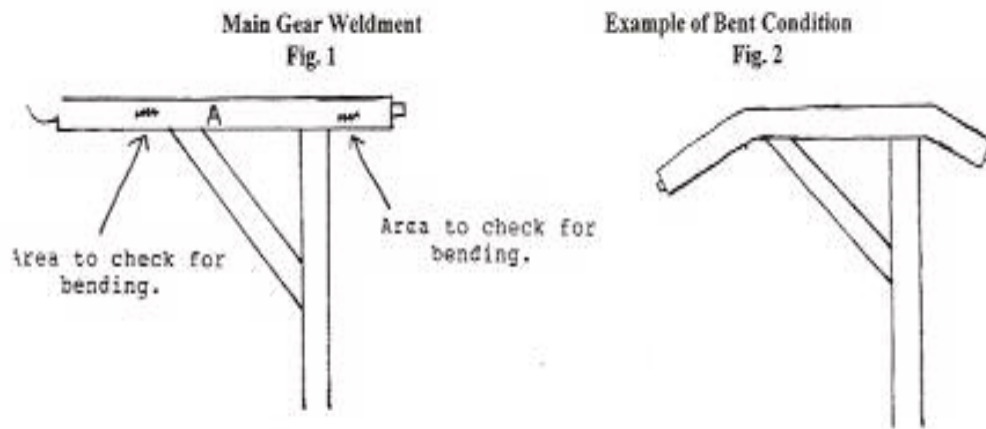
There is a possibility of the upper horizontal tube bending near the vertical supports on the gear weldment, due to excessive landing loads. This can eventually fatigue, crack and cause gear failure.

Inspect upper horizontal tube (A). Replace gear weldment if bent. The cost is \$145. The part # for 360's is GM001-2L and 2R, the part # for 235's is GM001 -1L and 1R.

Lancair now sells improved main gear shock absorbers which greatly reduces loads into the gear weldments on landing. Cost is \$1,195.00. Call Vern to order any parts you need.
