**SERVICE BULLETIN**

**SB056-0600**

Subject: Lancair IV and ES Rudder pedal weldments

Date: 21<sup>st</sup> June, 2000

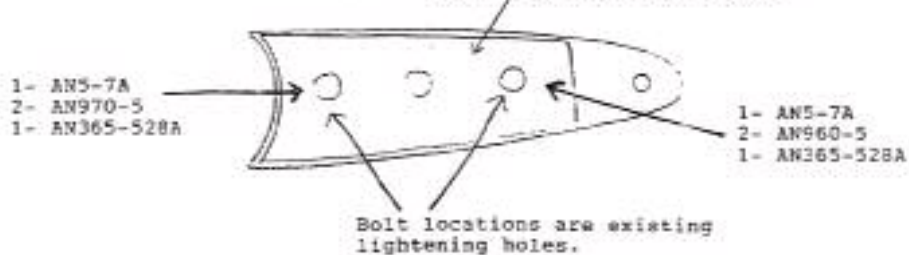
**Side View of Tab  
Fig. 2**

Early attach braces for the rudder cables did not have doublers welded onto the tabs for side loading. Because of any minor misalignments of the rudder cables, it may be possible for the attach braces of the rudder cables to bend. Thereby reducing rudder movement.

Inspect to see if your rudder pedal weldments have the doublers. If there are no doublers, check for bending. If they are bent, a 1/4" stiffener doubler needs to be installed between the tabs. The doubler is bolted in between the tabs using two AN5 -7A bolts, and washers on both sides. Use the tab as a template to make the doubler. The 1/4" aluminum can be purchased through Lancair.
