**SERVICE BULLETIN**

**SB060-1001**

Subject: Legacy Inboard Gear Doors Reinforcements (Serial Numbers)

Status: Mandatory Compliance for Version 1 Inboard Gear Doors

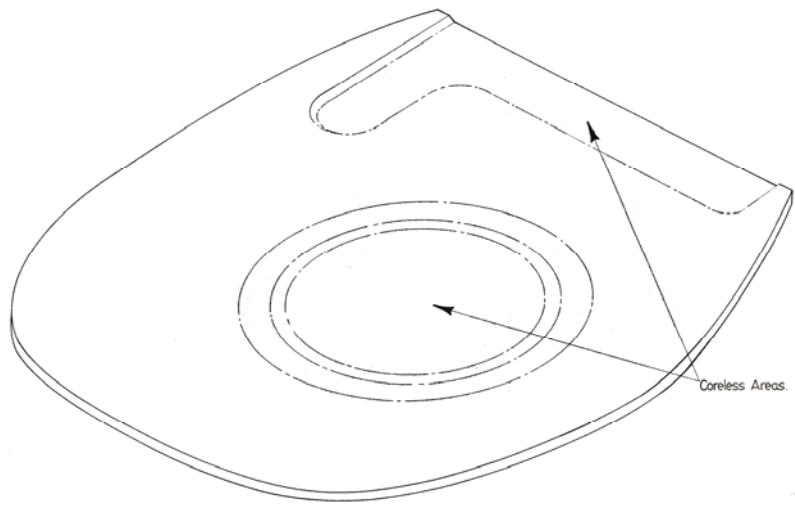
Figure 1: Version 1

Version 1 of Left Inboard Gear Door: Serial numbers 2067 and below

Version 1 of Right Inboard Gear Door: Serial numbers 2072 and below

2. If you have a version 1 door, follow the instructions of blueprint #4762 and modify the door accordingly.

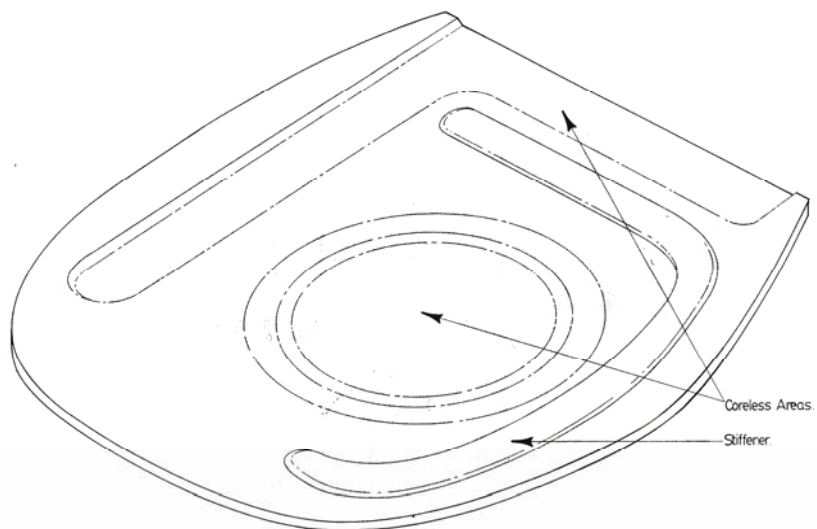
Figure 2: Version 2

Version 2 has later serial numbers than those of version 1.

This bulletin does not apply to version 2.
