INSPECTION AND REPLACEMENT OF NOSE GEAR DRAG LINKS

Lancair IV, IV-P, IV-PT, and Legacy

SERVICE BULLETIN SB077-0518

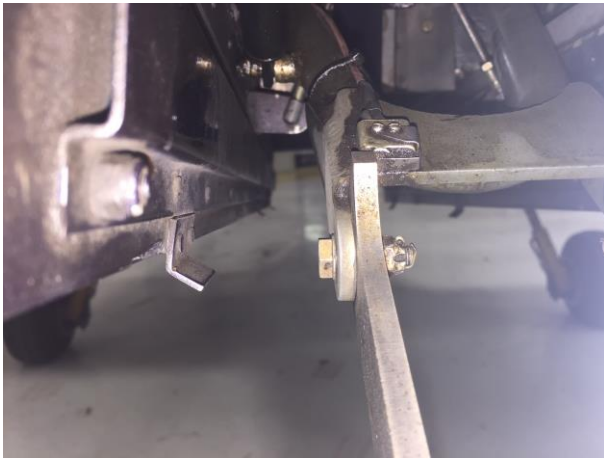
Figure 1
Original Design Lower Drag Links

- 6.1 Determine if the aircraft is equipped with the original or improved design lower drag links. The original upper and lower drag links were joined by two pivot bolts with cotter-pinned castle nuts that allow them to pivot on the bolts during gear retraction (Figure 1). The improved lower drag links added a bronze bushing to each of the lower drag links at the center pivot point (Figure 2). The bronze bushings are designed to be securely bolted to the upper drag link so that the pivot point becomes the interface between the new bushings and the lower drag links.

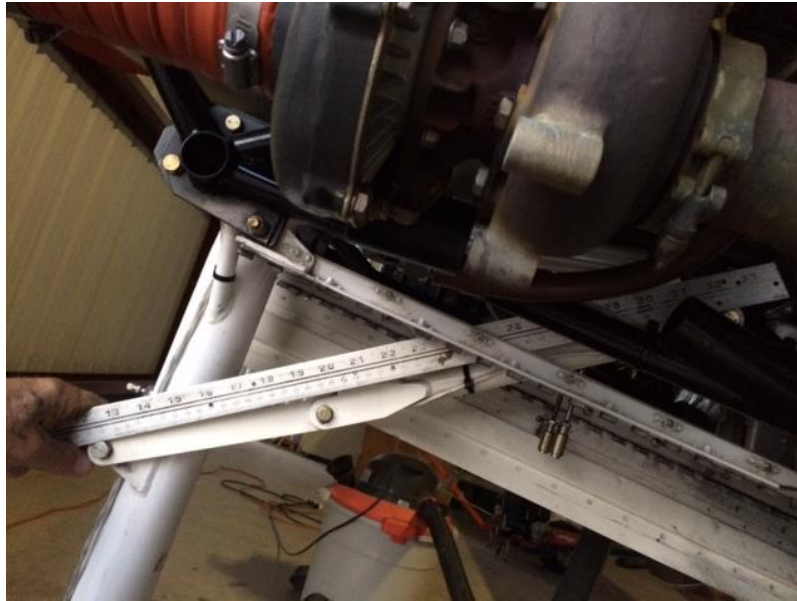
Figure 3

- 6.2.1** Aircraft equipped with the original steel-on-steel pivots (without the bronze bushings) will have a bolt with a castle nut and it is secured with a cotter pin.
- 6.2.1.1** Using a straightedge, check that the drag links are over-center shown in Figure 3. There is no "over-center distance" specified, but a range from $\frac{1}{4}$ " to $\frac{1}{2}$ " as measured from the centerline of the pivot bolt joining the upper and lower links is ideal.
