INSPECTION AND REPLACEMENT OF NOSE GEAR DRAG LINKS

Lancair IV, IV-P, IV-PT, and Legacy

SB078-0722

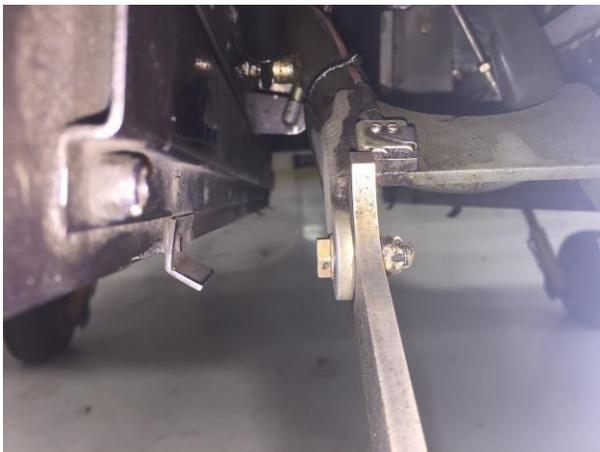
Figure 1
Original Design Lower Drag Links

- 6.1 Determine if the aircraft is equipped with the original or improved design lower drag links. The original upper and lower drag links were joined by two AN4 pivot bolts with cotter-pinned castle nuts that allow them to pivot on the bolts during gear retraction (Figure 1). The improved lower drag links added a bronze bushing to each of the lower drag links at the center pivot point (Figure 2). Both styles of Lower Drag Links are **superseded** by the new components detailed in this Service Bulletin (PN 433-1001, Lower Drag Link LH and PN 433-1002, Lower Drag Link RH).

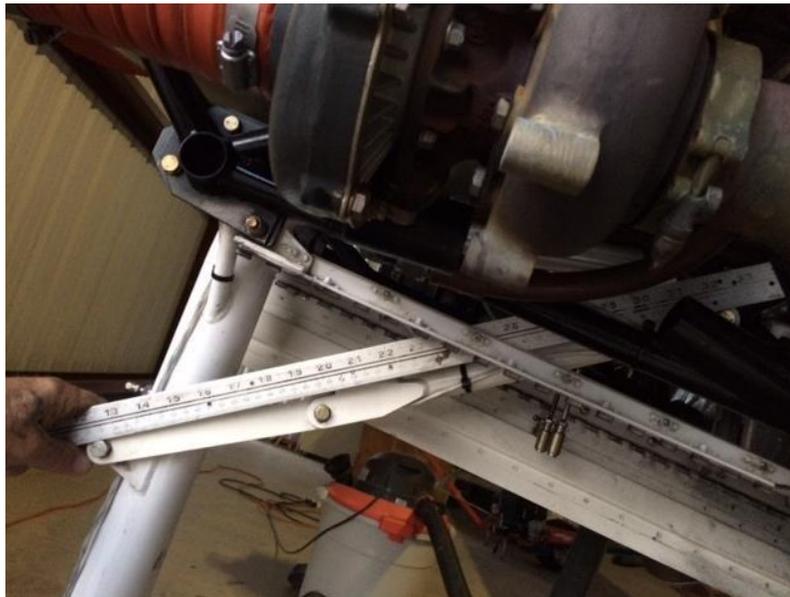
Figure 3

- 6.2.1** Aircraft equipped with the original steel-on-steel pivots (without the bronze bushings) will have a bolt with a castle nut secured with a cotter pin. Aircraft equipped with the improved pivots will have a tension bolts and locking nut.
- 6.2.1.1** Using a straightedge, check that the drag links are over-center shown in Figure 3. There is no “over-center distance” specified, but a range from $\frac{1}{4}$ ” to $\frac{1}{2}$ ” as measured from the centerline of the pivot bolt joining the upper and lower links is ideal.

and the upper link acts as the initial pivot point for the assembly. If wear in the joint is sufficient to allow it to move over-center as measured in step 6.2.1.1 above, the nose gear is restrained from retracting at touchdown only by the combined hydraulic and gas spring pressure. If either fails, the nose gear could retract upon a normal touchdown.

- 6.2.1.4** If the above test indicates the drag link pivot point moves past, or close, to the over-center position, replacement of the drag link assembly is dictated. Once this joint develops free play, the wear rate will increase exponentially until it fails.

- 6.2.1.5** In most cases, replacement of the two lower drag links with the superseded design lower drag links and the correct installation of the new hardware between the upper and lower links will correct this problem. If the holes in the upper over center link have been worn excessively, replacement of this part is also indicated.

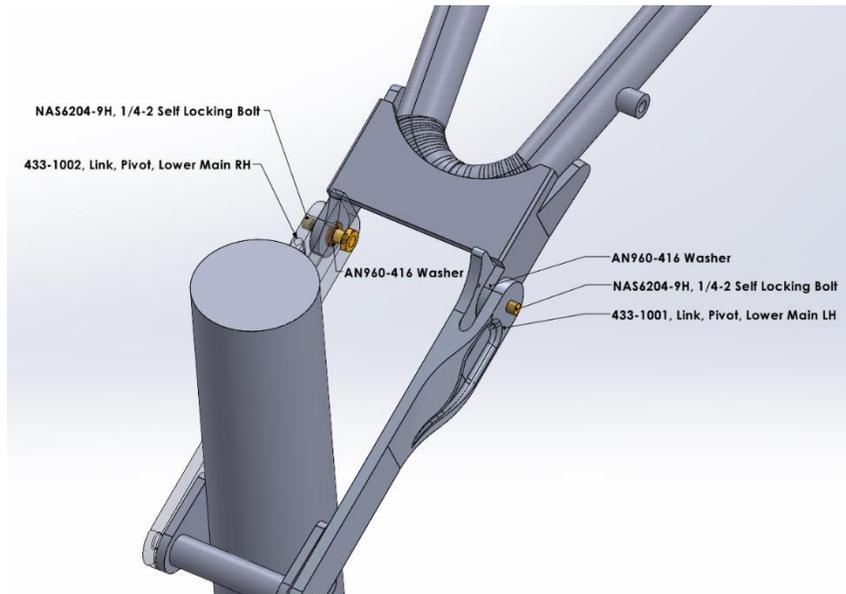
Figure 4

SB074-0111 applies to both over center link tab configurations shown in Fig. 4, SB074-0111 also addresses the installation of a Hydraulic actuator end with a spherical bearing. For further details on the inspection please refer to SB074-0111.

- 7.2** Procedure (See Figure 2 and 4):
- 7.2.1** Lubricate lightly and install the new 433-1001 Lower Drag Link LH and 433-1002 Lower Drag Link RH.
- 7.2.2** Install the new lower links to the over center link using NEW NAS6204-7H Self Locking Bolts (head on inside of the assembly, threads going outboard) and AN960-416 Washers.

NOTE: The Upper Over center Link Assembly has been upgraded to a stronger part by SB074-0111. If you have not complied with this service bulletin, it is recommended that SB074-0111 be incorporated at this time.
