SERVICE BULLETIN

SB028-0796

Subject: Lancair IV Inboard Spar Closeout Inspection

Status: Mandatory Compliance

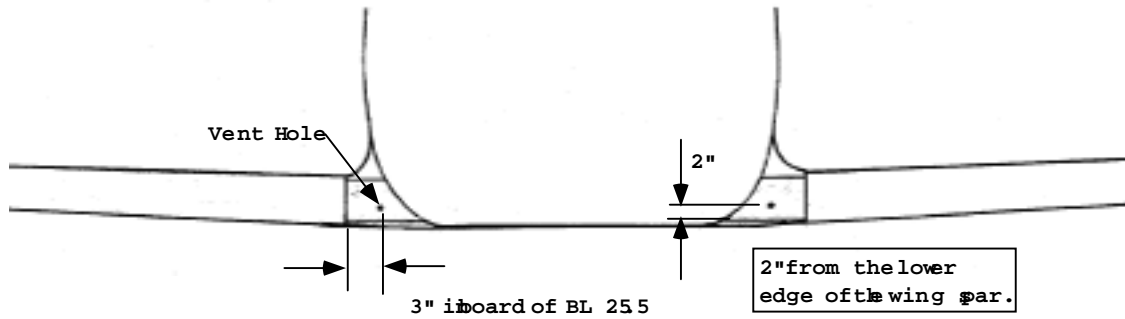
Figure 1

Locating the Drain/Vent Hole Position

1. Remove the access panel in the wing fairing aft of the main spar.
2. Drill a 1/4" hole 2" above the bottom edge of the main spar cap into the aft side of the spar web closeout. Be ready to plug the hole or use a piece of tygon tubing to drain the fuel in the cavity. NOTE: IT IS EXTREMELY IMPORTANT NOT TO DRILL THE HOLE LOWER THAN 2" ABOVE THE SPAR CAP. DRILLING THE HOLE TOO LOW COULD INFLICT DAMAGE TO THE LOWER SPAR CAP.

3. After drilling this hole and if there is no fuel leaking out, you're done. This is now your new main spar inboard vent hole.
4. If you do have fuel in the cavity, drain the fuel out of the wing(s), remove the wing, and proceed with the following repair. (Drill an additional 1/8" hole into the face of the main spar at approximately the same location as the 1/4" hole.)
5. With the leading edge pointing down, air dry the closeout area with the a blow gun or fan. This should be done in a well ventilated area. **Be very careful not to over pressurize the close out area.**

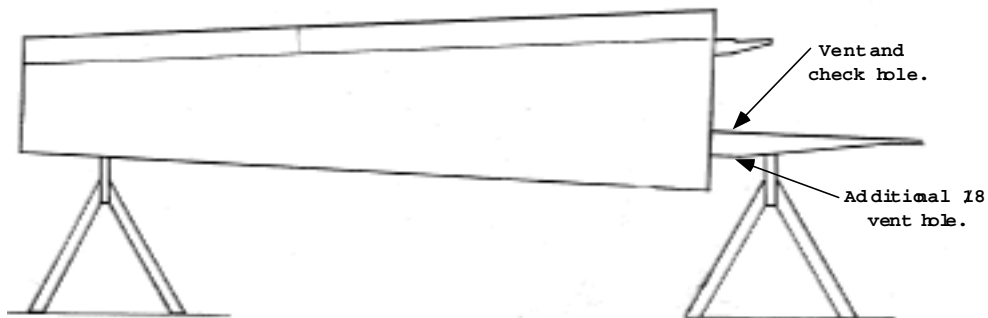
Figure 2

Drying the Close Out Area

6. Mix up two cups of Jeffco fuel tank sealant. This may seem like more than is necessary, but the excess will be drained out later. (For this step the temperature should be at least 72°F or above. If not, the viscosity of the sealant may prevent proper penetration into the areas that are causing the leak. Pour the 2 cups of sealant into the hole). Attach a hose or fuel line to the fuel pickup on the BL 25.5 rib and tape that hose into a vacuum cleaner hose.

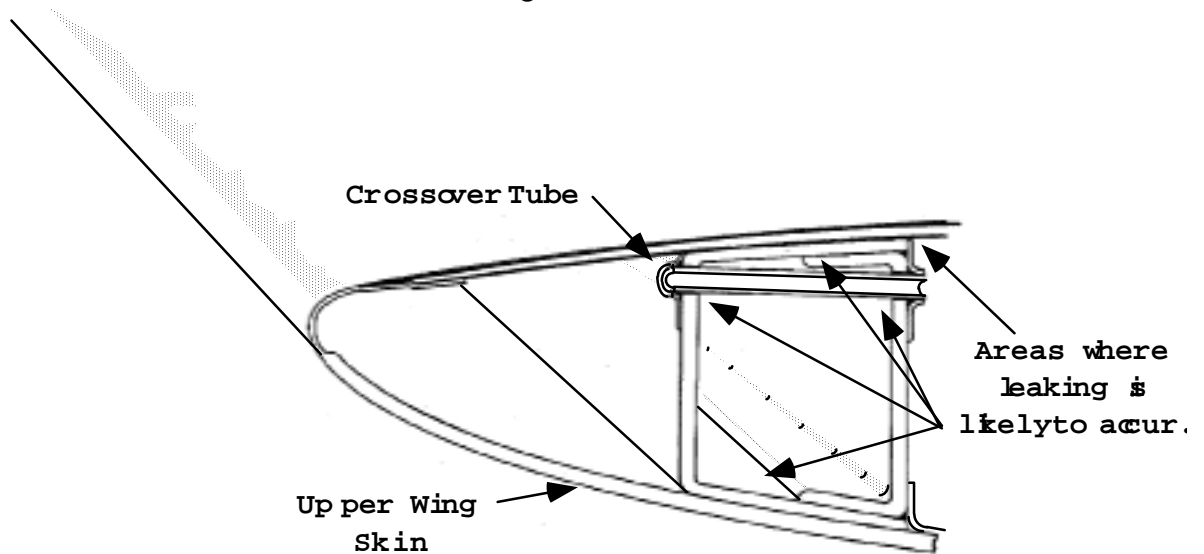
Figure 3

7. There are two possible areas causing the leak. The most likely source is through the area between the spar and the inboard spar closeout. A second source of leakage may be around the fuel crossover tube. Keeping this in mind, rotate the wing (very slowly) such that the sealer will flow into these areas. Apply the vacuum to the fuel tank during this process. This will allow the sealant to get drawn into the holes that are causing the leak. **NOTE: A small shop vacuum cleaner is ideal for this process. The vacuum source should be removed as soon as you think you have sealed the possible leak areas.**

Areas That Might Leak

8. Drain the excess fuel tank sealant out of the cavity. (Use some of this excess sealant to paint on a piece of cardboard. Check the cardboard a couple of hours later to make sure it has cured enough to do a leak check).
9. Before the sealant has fully cured, perform a fuel tank vacuum test. It is preferable to draw a vacuum versus pressure to the wing tanks. Hook up an altimeter and monitor the gage. If it holds altitude, you're done, if not, repeat the process. (Note: There is also a possibility that the leak could stem from a different source: check all possibilities if you still have a leak).

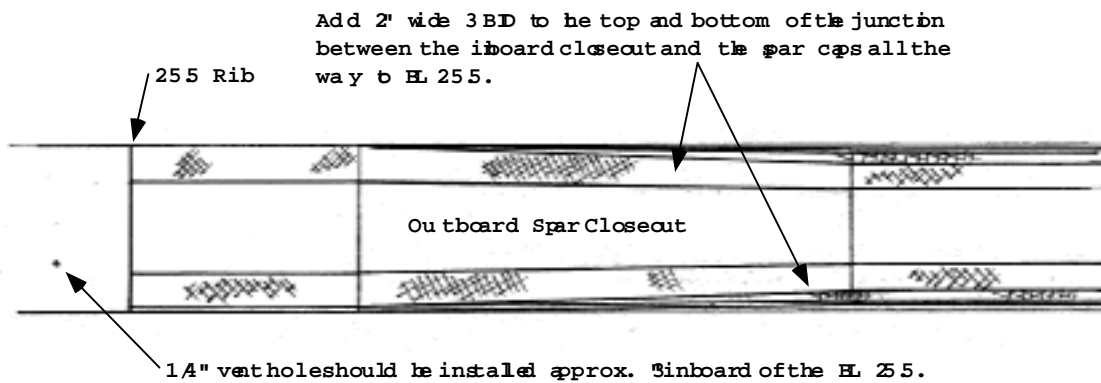
Figure 4

3 BID

1. Apply 2" wide 3 BID to the top and bottom of the junction between the inboard closeout and the spar caps. Refer to the figure.
2. Verify that you have a vent hole in the spar closeout inboard of the 25.5 rib.
3. Apply an extra coat of fuel tank sealer around the fuel tank crossover tube.

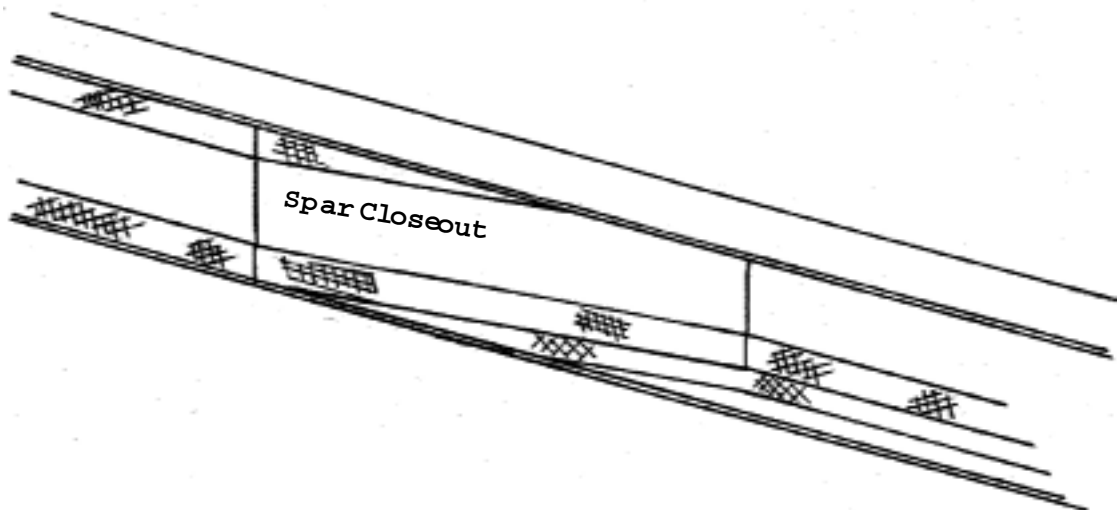
Figure 5

3-D View
