INSPECTION AND REPLACEMENT OF NOSE GEAR DRAG LINKS

Lancair IV, IV-P, IV-PT, and Legacy

SB078-0722

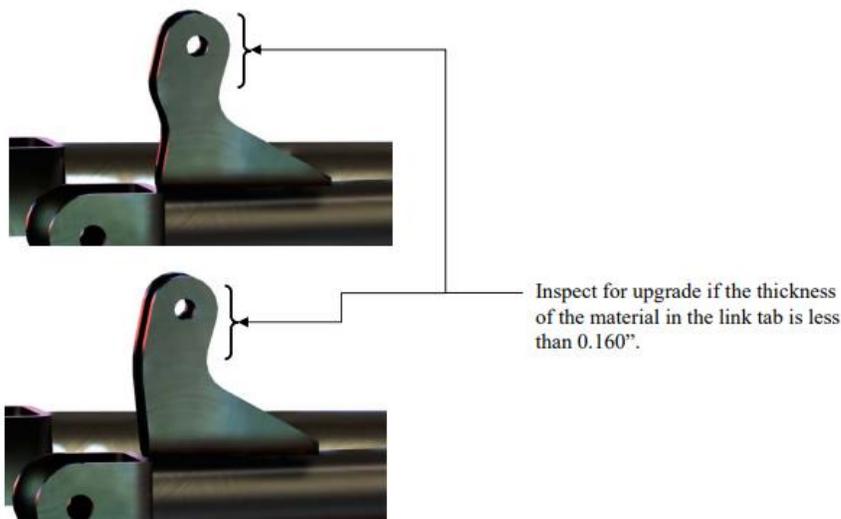
Figure 4

NOTE: The Upper Over center Link Assembly has been upgraded to a stronger part by SB074-0111. If you have not complied with this service bulletin, it is recommended that SB074-0111 be incorporated at this time.

SB074-0111 applies to both over center link tab configurations shown in Fig. 4, SB074-0111 also addresses the installation of a Hydraulic actuator end with a spherical bearing. For further details on the inspection please refer to SB074-0111.
